PEACHLAND HUB SOCIETY
PEACHLAND HUB

BUILDING ASSESSMENT REPORT

Date: June 9, 2022

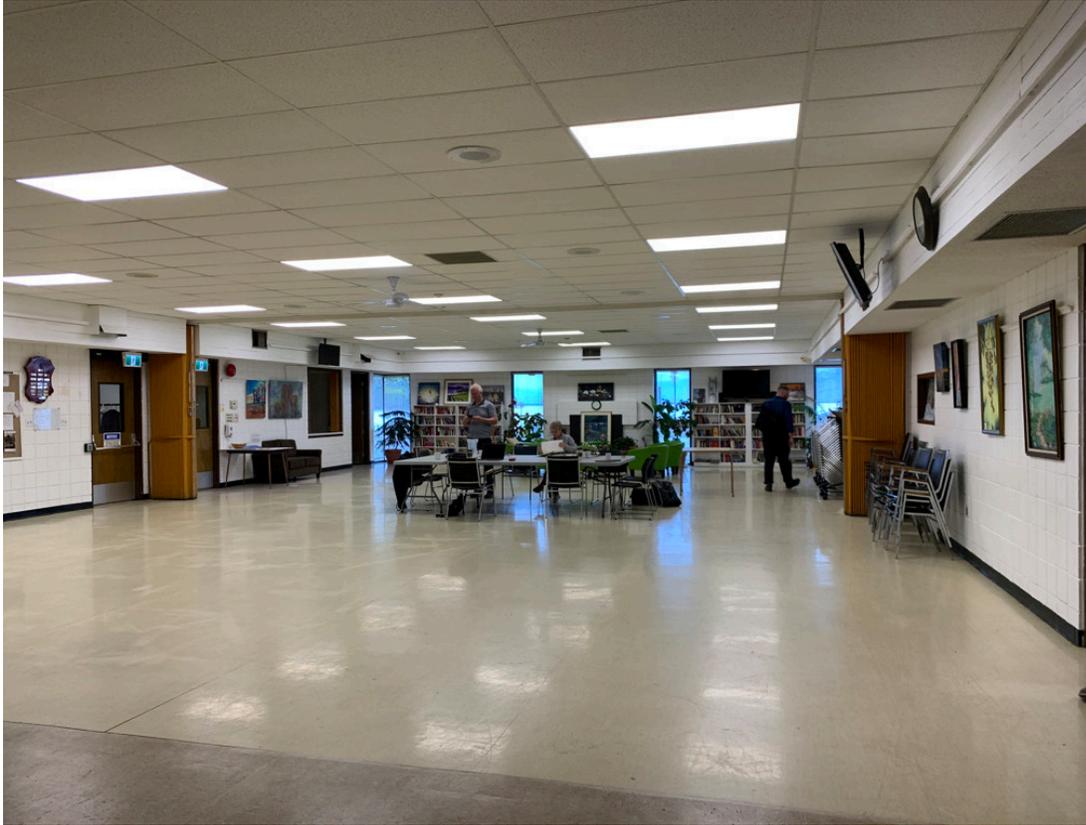
View of Community Hall looking to Fireplace Room.

A non-working wood burning fireplace and chimney is located at the east side of the space.

- If Hall is renovated, explore increasing ceiling height and increasing natural daylighting.
- Provide direct connection to exterior gathering spaces.
- Remove direct access to washrooms, offices and kitchen for acoustic performance and privacy.
- Replace all finishes, and add acoustic materials to enhance performance.
- Review mechanical system.
- Add AV Room and equipment.

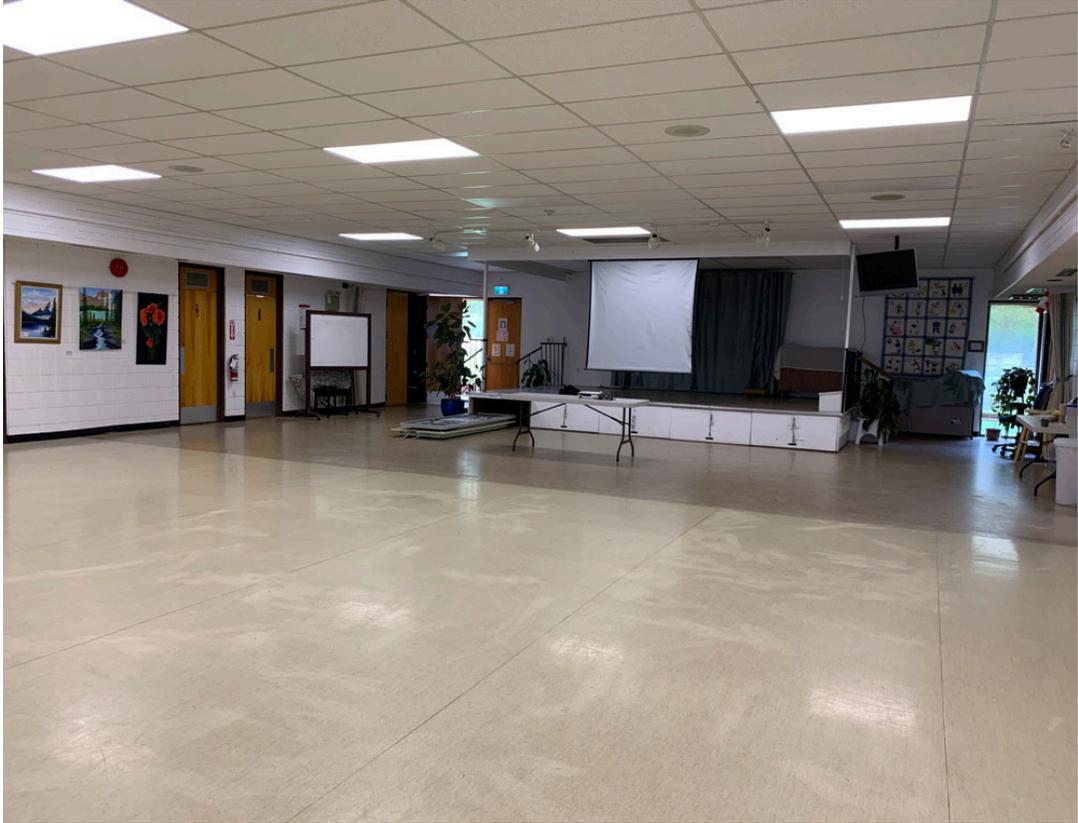
View of Community Hall looking to Stage Room

Stage: There is a small stage located at the west end of the space. It is a wood platform and is not accessible.

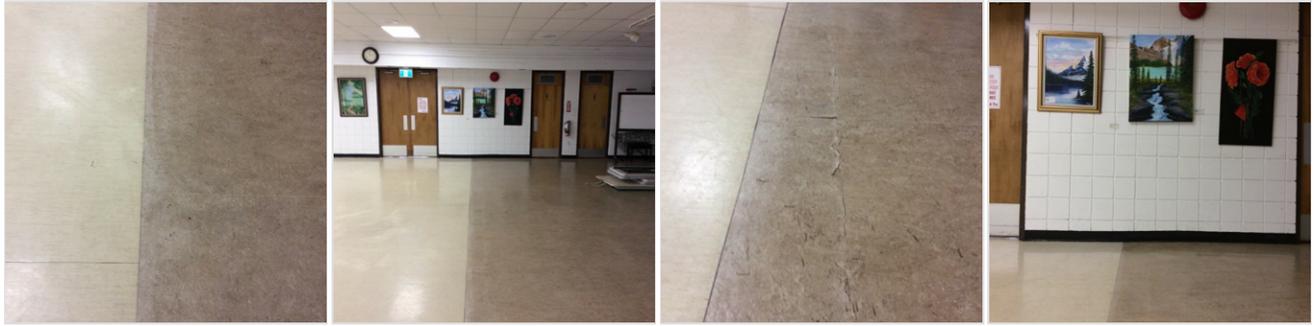
1.10 Photos at 1987 addition
May 25, 2022
