PEACHLAND HUB SOCIETY
PEACHLAND HUB

BUILDING ASSESSMENT REPORT

Date: June 9, 2022

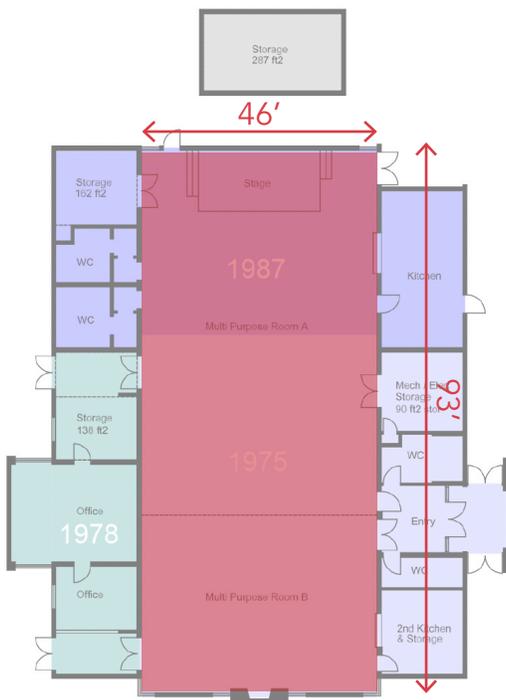
Key Plan - Ground Floor

The flooring in the seating area is sheet vinyl throughout, applied directly to the concrete slab, and is nearing the end of its life. There is some wear at the junction with the 1987 addition.

A non-working wood burning fireplace and chimney is located at the east side of the space.

Stage: There is a small stage located at the west end of the space. It is a wood platform and is not accessible.

- If Hall is renovated, explore increasing ceiling height and increasing natural daylighting.
- Provide direct connection to exterior gathering spaces.
- Remove direct access to washrooms, offices and kitchen for acoustic performance and privacy.
- Replace all finishes, and add acoustic materials to enhance performance.
- Review mechanical system.
- Add AV Room and equipment.

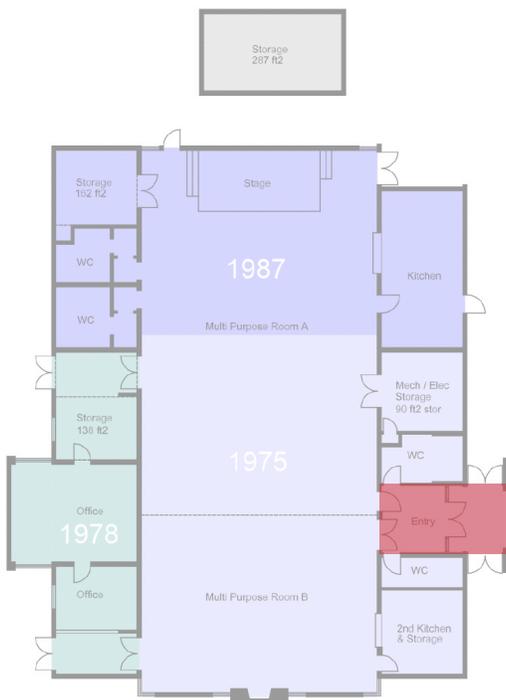
WALLS: The majority of the wall finishes are painted GWB on insulated wood stud walls. Concrete block at north elevation of Vestibule. Natural daylight is limited with light from glazed panels at exterior doors.

DOORS: Aluminum Entry Door system with automatic openers. No glazed film, for safety, at sidelites.

Demolish existing vestibule. Relocate and provide new entry with adequate space for pre-function and increased accessibility. Vestibule area may be reused for other function.

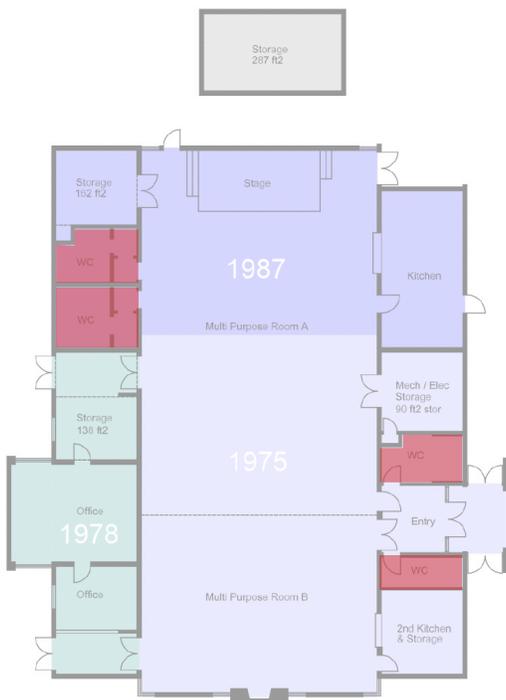
Washroom fixtures are dated and approaching the end of their life.

Demolish existing washrooms. Relocate and expand washroom areas to meet new occupant load. Include minimum of two universal accessible unit washrooms - one with a change table. Include tile flooring, tile walls, where exposed to moisture, low flow fixtures. Centrally locate in a location that is acoustically separated from the Hall.

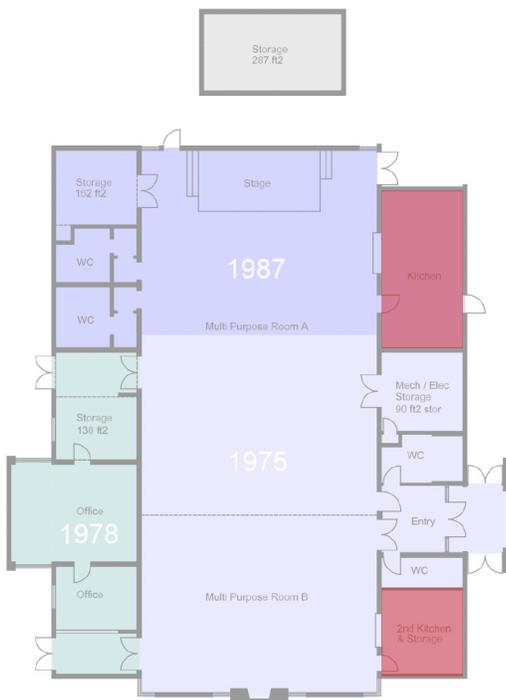
There are two kitchens - the small original 1976 kitchen, and the main kitchen located in the northwest corner. Both areas are accessed directly from the Hall. The main kitchen includes two gas fired ranges with a hood system above. The smaller kitchen is used primarily for serving.

Redo/expand kitchen space with all new finishes, acoustic ceiling, additional power, new lights and update ventilation system. Provide new electric induction cooktops and stainless steel counters and new cabinets. Use stainless steel mobile shelving system where possible.

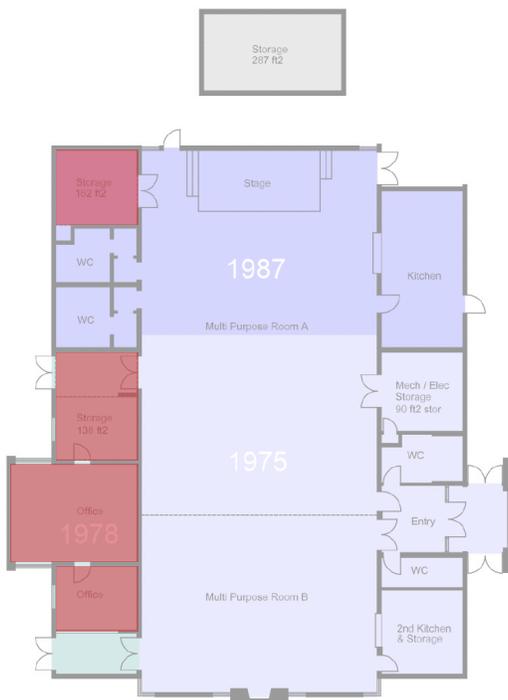
Located in the 1978 addition, the office and storage area are accessed through the Hall. There are two additional exits to Cousins Field. The spaces area currently being used as a small office and as a workshop/storage area.

Relocate office functions. Explore opening up this area to the park. Redo all finishes.

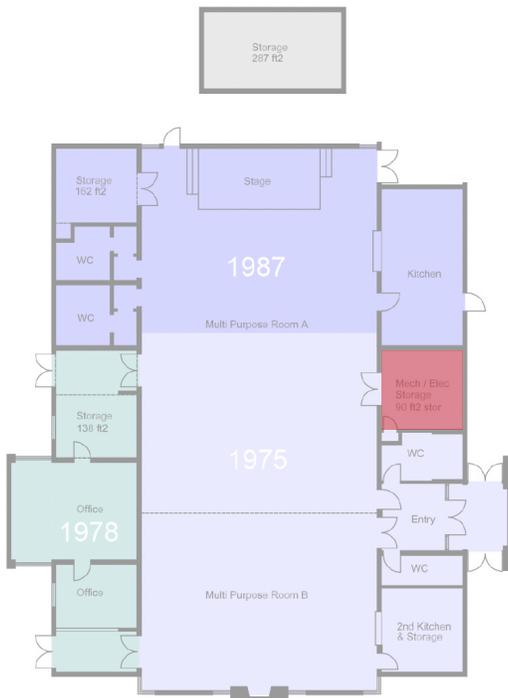
The mechanical/electrical room is accessed directly from the Hall. It is currently also being used as a storage room (none code compliant use). Refer to mechanical and electrical reports for further information.

Explore relocation of the electrical equipment/room during the design stage, as this space is currently located within the 2'-0" freeboard flood zone.
